SITE VISIT REPORT
NAVAJO ABANDONED MINE LANDS RECLAMATION PROGRAM

DATE (S) OF VISIT:	31 January 2019
MINE/PROJECT NAME:	USEPA Region 9, Cove Mesa V Haul Shaft Closure Project
DURATION OF VISIT:	1:30 pm – 5:30 pm
PURPOSE OF VISIT:	Construction Progress Inspection

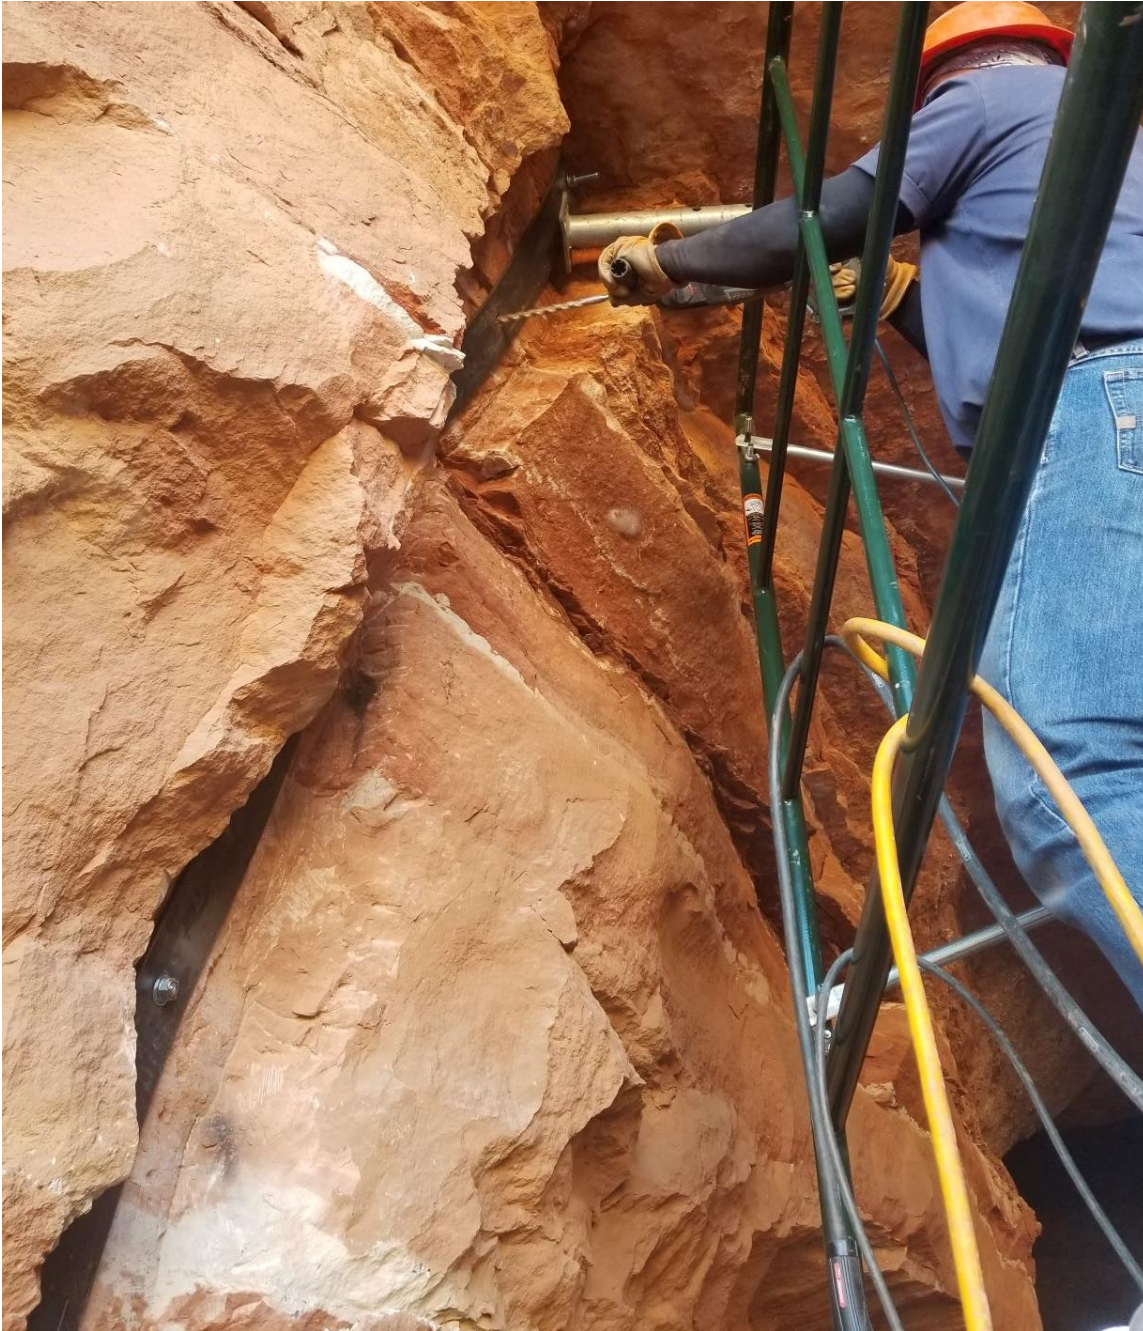
Drilling rock and installing anchor bolts on Thursday, 31 January 2019

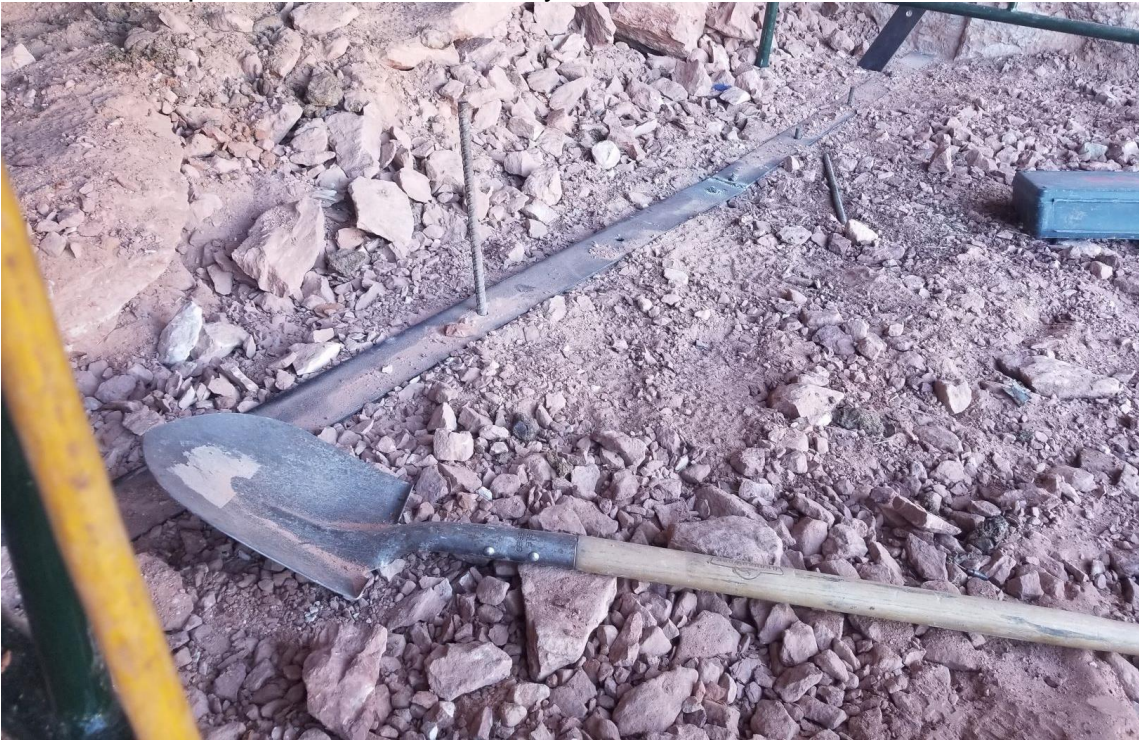
Bottom steel plate installed, 30 January 2019, note 5/8" rebar.

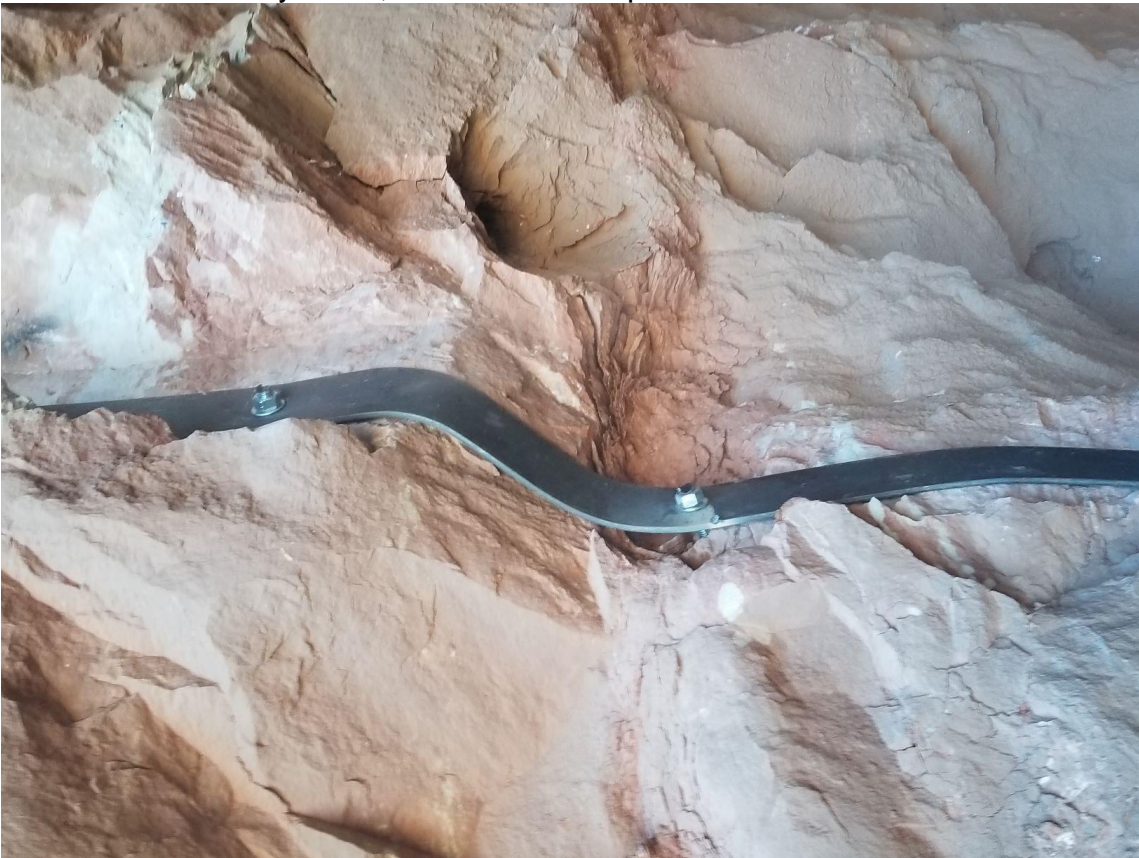
Photo tilted side ways to fit, shows the steel plate frame connected to rock wall.

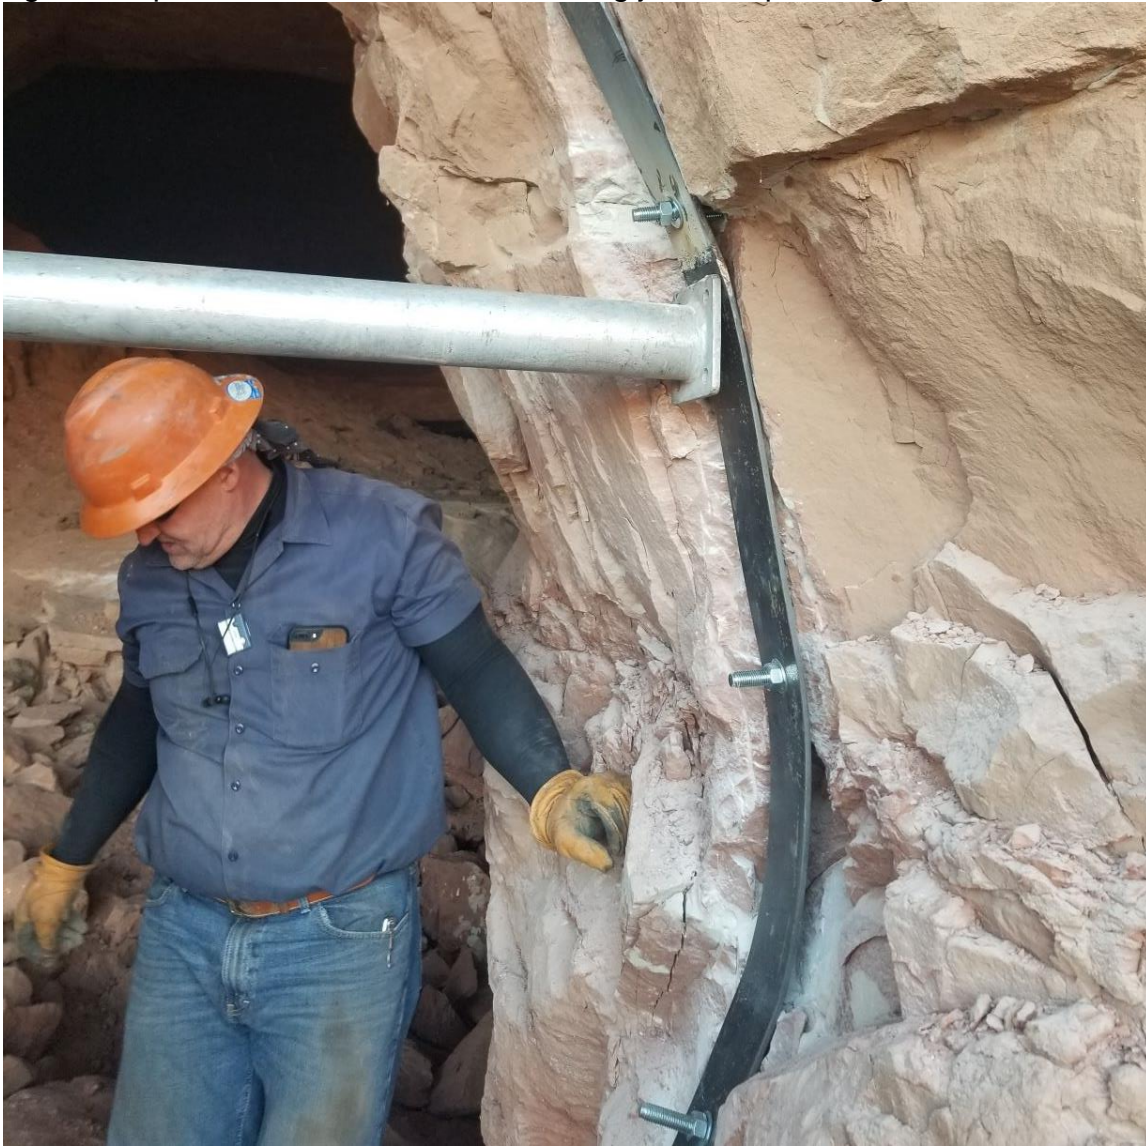
Right steel plate installation, note the shoring jack compressing the metal to rock.

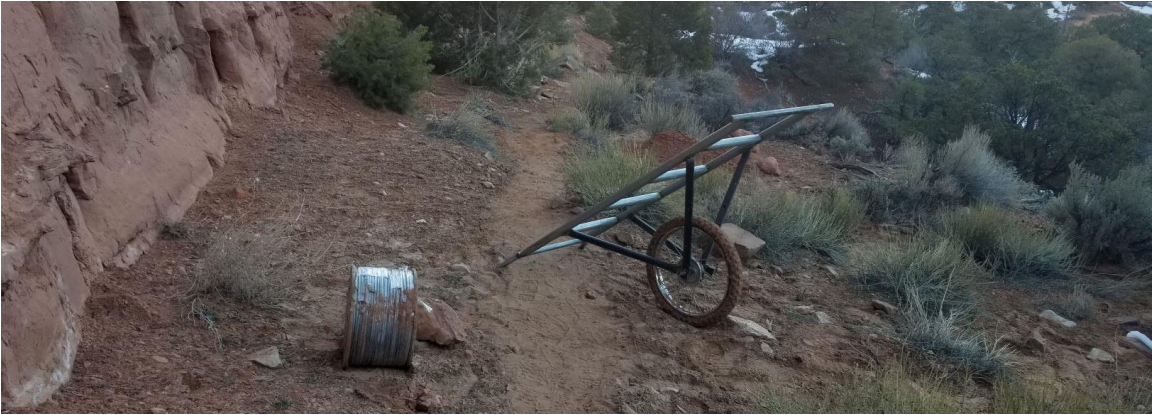
Two hundred fifty-pound cable spool delivered with Clawson's delivery device.

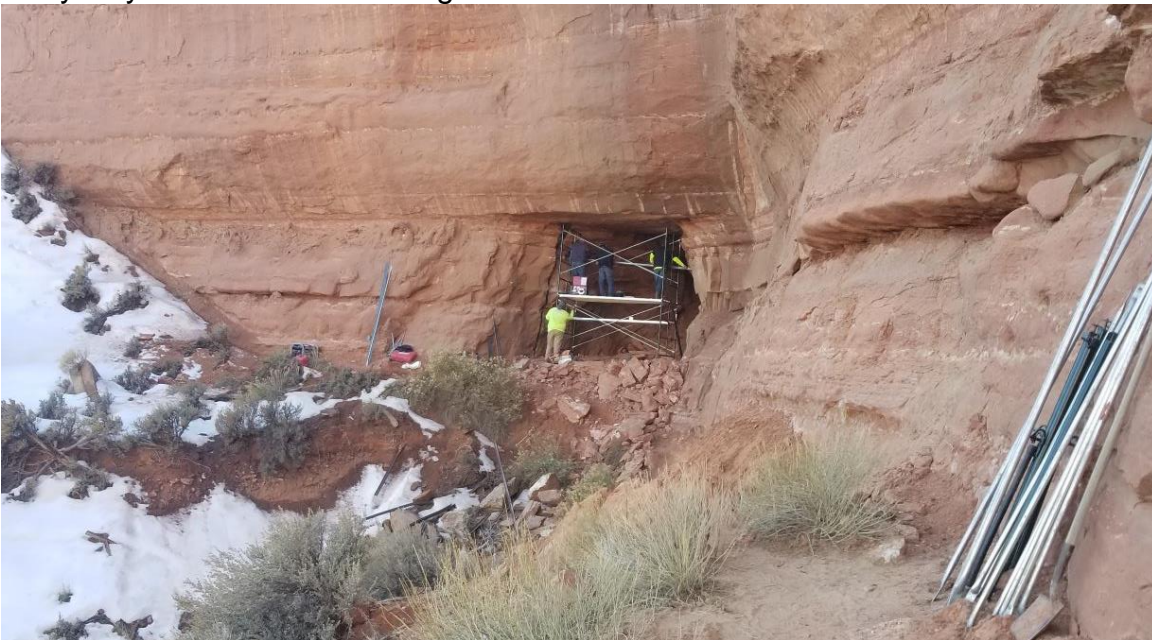
The contractor completed the rock and earth work at haul shaft entry way. Haul shaft entry area was flat with a good work area, but it was not leveled, it is tilted to one side, see pictures below. The bottom steel plate was installed with 5/8" concrete reinforcement bars (18" OC) with lengths ranging from 18" to 48" depending when competent rock was encountered. The contractor was in the process of installing the left side steel frame plate. Left side as you look at the opening from the outside. A shoring jack (15-20 feet) is used to form the 1/4" steel plate to the rock wall. Once the steel plate was in contact with the rock a (5/8" X 12") anchor bolts are installed. In order to install the anchor bolts the rock is drilled with concrete drill bit (5/8" X 12") aligned by the pre-drilled holes in the steel plate, spaced 18" apart. After the corresponding holes were aligned the anchor bolt is installed and tighten. The anchor bolts have a wedging end at the tip. Even through the shoring jack and anchor bolts set the steel plate close to the rock, NAMLRP is recommending non-expansive grout to secure the gaps between the steel and rock. This seal will secure the steel plates and bolts from corrosion and rust. The contractor finished the left side and started the right side. Bottom, left, and right plates were installed at the end of the day. Next week they will start with the top plate.

Entry way floor is tilted to the right.
